January 26, 2018

Re: Task Order 17 – Sewer Inspection Results Engineering Support

The following is our summary review of the results of the 2017 sewer system inspection that was conducted by Ted Berry Company, per Task Order No. 17. The scope of this Task Order is to provide ongoing engineering support including a review of the sewer inspection results, improvement recommendations, and support with implementation of recommendations.

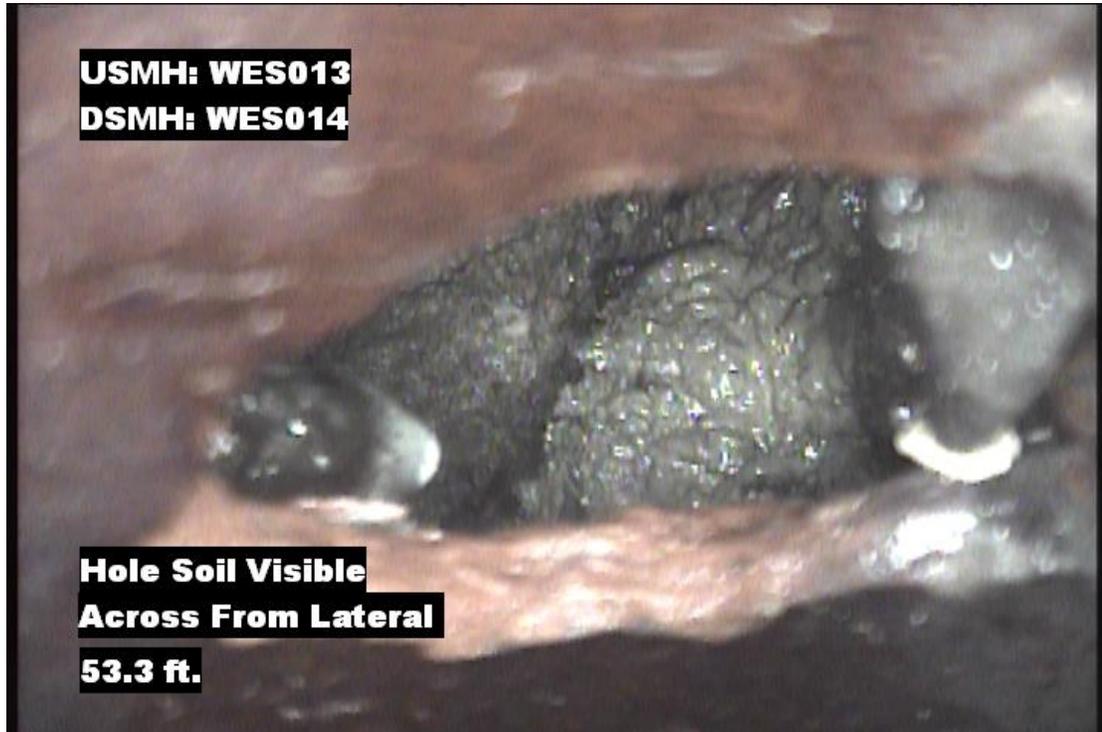
The sewer main and manholes along this section of Western Avenue expected to be impacted by the full reconstruction project are some of the oldest in the Hampden system and are in poor condition. Piping consists of vitrified clay pipe (VCP) and manholes are constructed of brick. There are numerous structural pipe failures, holes, and active infiltration throughout this section of sewer main. Several of the manholes also have structural failures with barrel-section fractures, missing brick and mortar, and active infiltration.

Figure 2: Example Hole in VCP

The condition of sewer along this section of Western Avenue warrants full replacement due to its poor condition.

- Replacement of all gravity sewer and service laterals along Western Avenue.
- Replacement of gravity sewer and service laterals on Dewey Street to minimize future disruption.
  - We recommend replacement through open-cut installation within the road right-of-way to occur in advance of or concurrent with the scheduled road rehabilitation project.

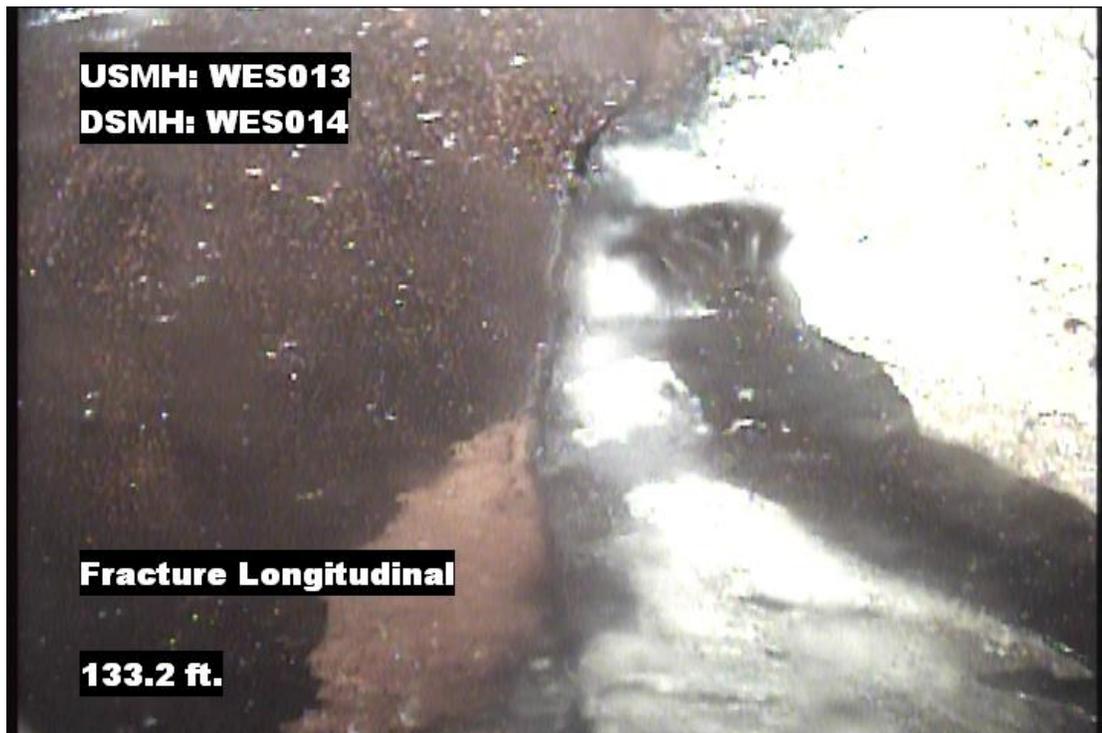
Figure 3: Example VCP Fracture

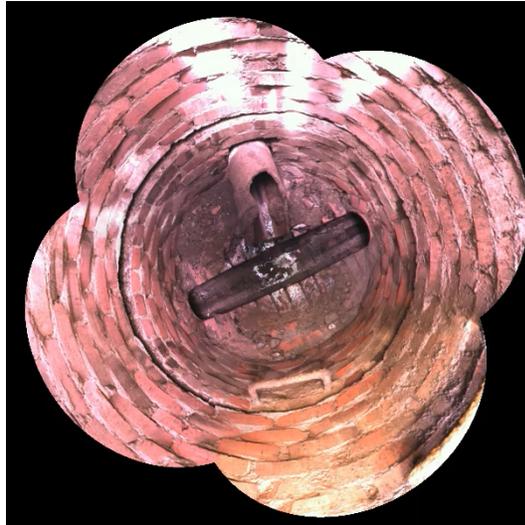
**Figure 4: Example Manhole Barrel Fracture**

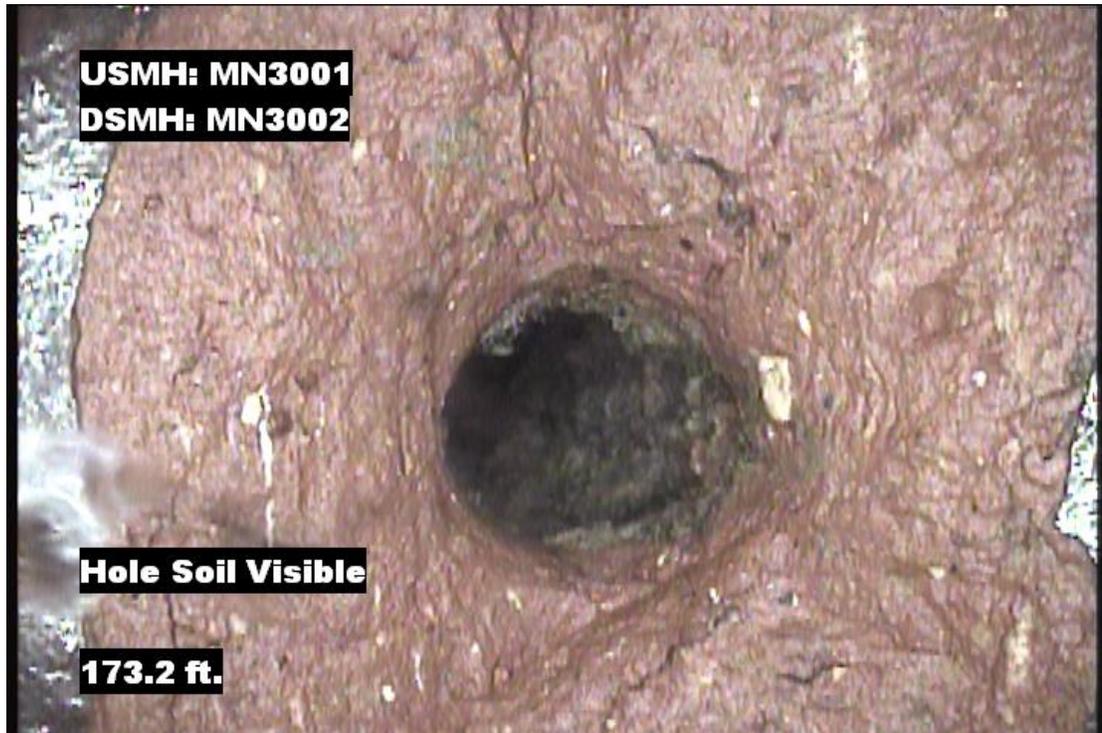
The sewer main and manholes along this section of Main Road North is some of the oldest in the Hampden system and in poor condition. Piping consists of vitrified clay pipe (VCP) and manholes are constructed of brick. There are numerous structural pipe failures, holes, root growth, and active infiltration throughout this section of sewer main. Several of the manholes also have structural failures with barrel fractures, missing brick, and active infiltration. Grease deposition has been a known issue in this section of sewer as it serves several restaurants, exacerbated by intruding service laterals and root obstruction. Figures 5 through 7 show examples of these issues from the sewer inspection.

Figure 5: Example Hole in VCP

The condition of sewer along this section of Western Avenue warrants full replacement due to its poor condition. We recommend replacement through open-cut installation within the road right-of-way.

As this area is scheduled for water main replacement in 2018 by the Hampden Water District, we recommend that the Town coordinate sewer replacement to minimize overall construction impacts. We do not recommend scheduling this work to occur while the MDOT Route 1A reconstruction project is in progress due to the combined impact of construction projects on the Route 1A corridor. Pavement and sidewalk restoration will be required for this project due to the location of the sewer. Coordination water main and sewer replacement

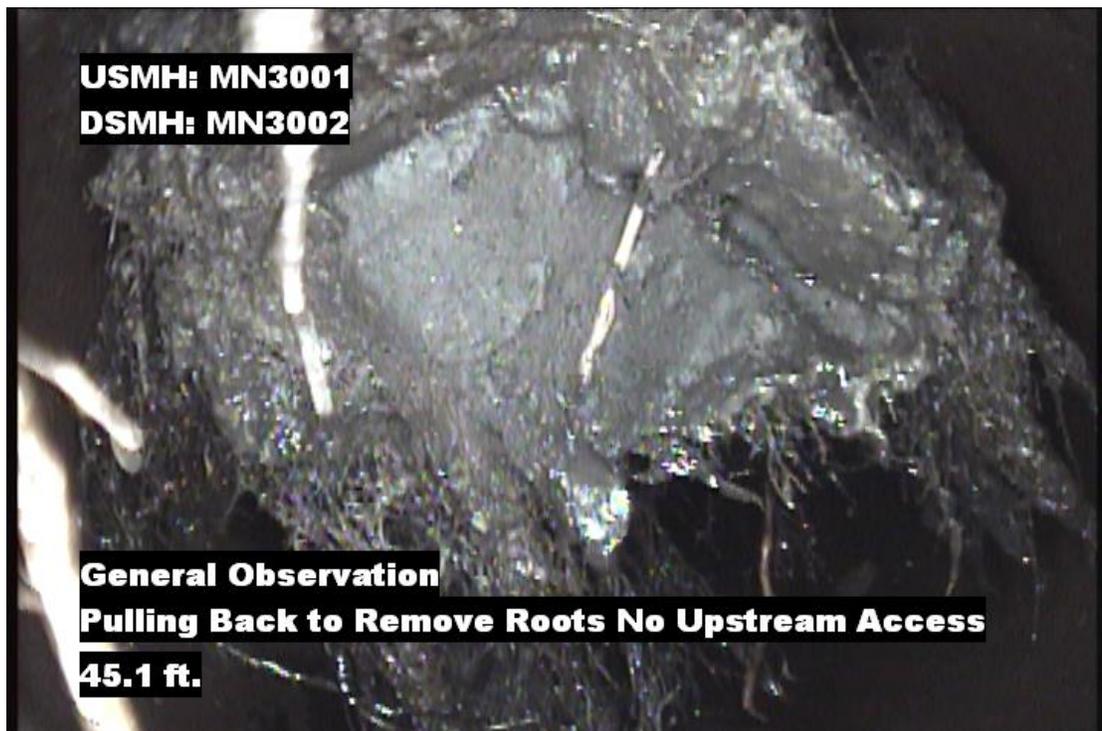
Figure 6: Example Root Intrusion

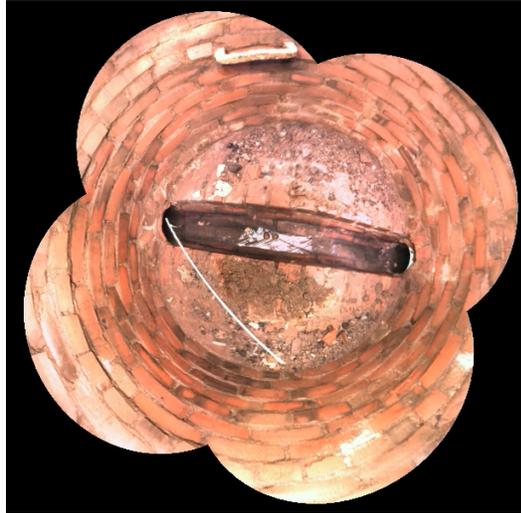
**Figure 7: Example I/I Evidence of Gravel in Sewer**
