## TOWN COUNCIL MINUTES

SEPTEMBER 4, 2012

**Town of Hampden  
106 Western Avenue  
Hampden, Maine**

Phase II Environmental Assessment – Hampden Academy  
1 Main Street North, Hampden, Maine

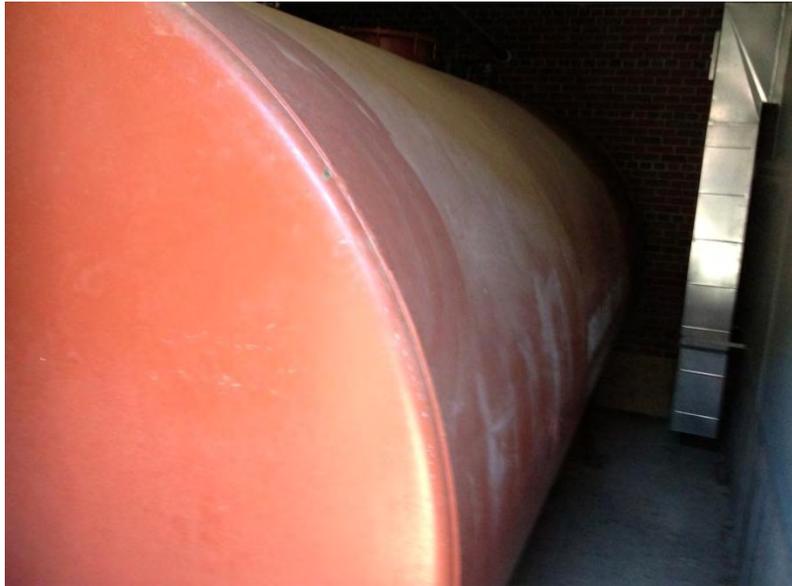
1

The tank was inspected and no visual surficial evidence of a release was noted. Photographs of the tank are included in **Appendix B**.

View of the end and side of AST-7

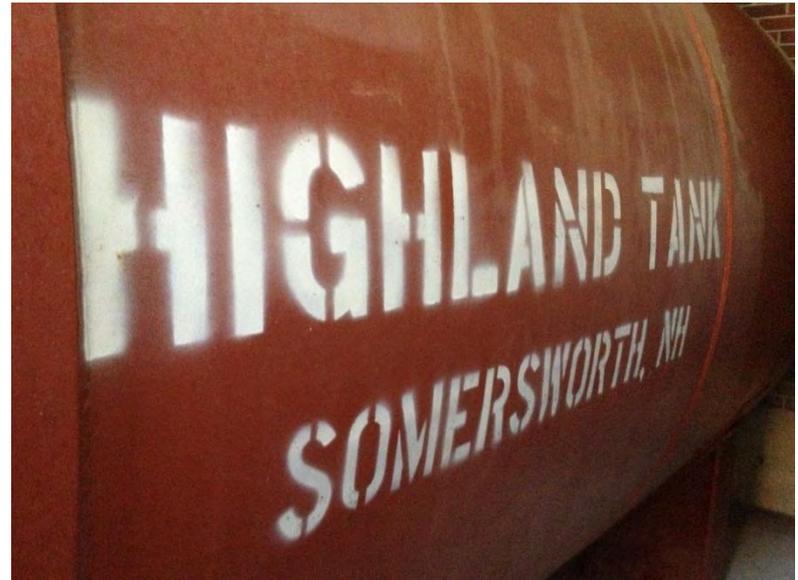
2

View of the side of UST-7

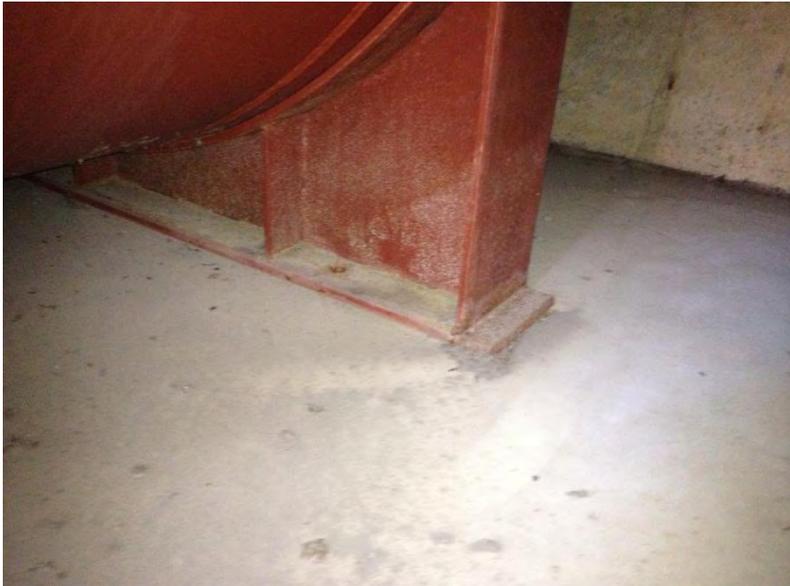
3

View of the concrete floor under AST-7

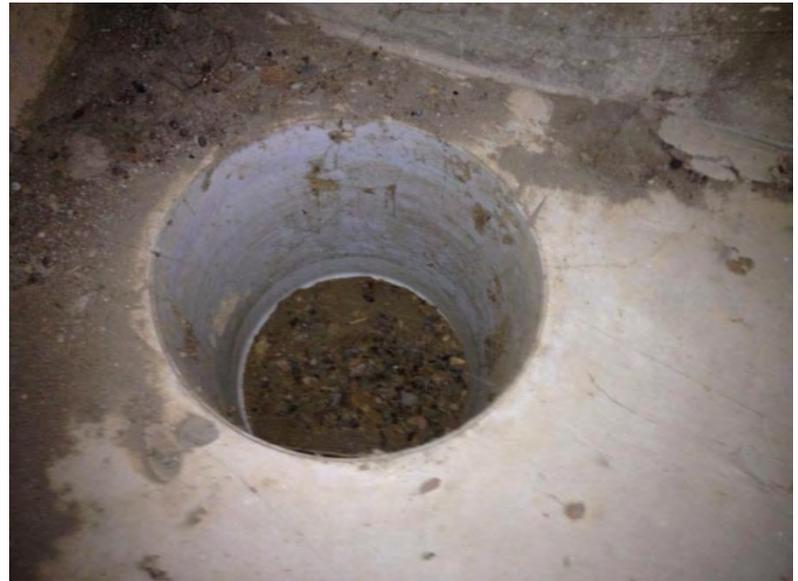
4

View of a plastic lined sump in the concrete floor  
adjacent to AST-7

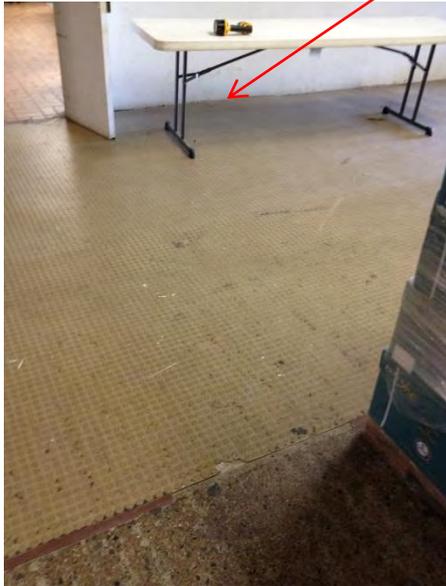
5

Results of the PCB bulk product sampling revealed PCB bulk product waste materials are present at the Site. Specifically, medium grey interior floor paint in Building 4 (BM-7), dark grey interior floor paint in Building 6 (BM-01), and light grey interior floor paint in Building 10 (BM-09) are considered to be PCB bulk product waste because sample results indicate that these materials contain PCBs at concentrations that are in excess of 50 parts per million (ppm). In addition, based on analytical results and observed conditions, medium grey floor paint in Building 6 (BM-02) represents PCB bulk product waste. Though the analyzed concentration of PCBs was less than 50 ppm, evidence of potential dilution was noted and until proven otherwise, this sample must be classified as containing PCBs in excess of 50 ppm. **Figure 5** depicts the locations of the collected suspect PCB bulk product samples, **Table 3** summarizes the laboratory results, and a copy of the laboratory report is included in **Appendix E**.

BM-1 (dark grey interior floor paint under plastic wear guard)

View of Floor in Building 6 near Cafeteria

- Additional PCB sampling is recommended to delineate the extent of PCB bulk product waste in Buildings 4, 6, and 10, and to determine if any associated porous materials in close proximity to the identified PCB bulk product waste have become contaminated.

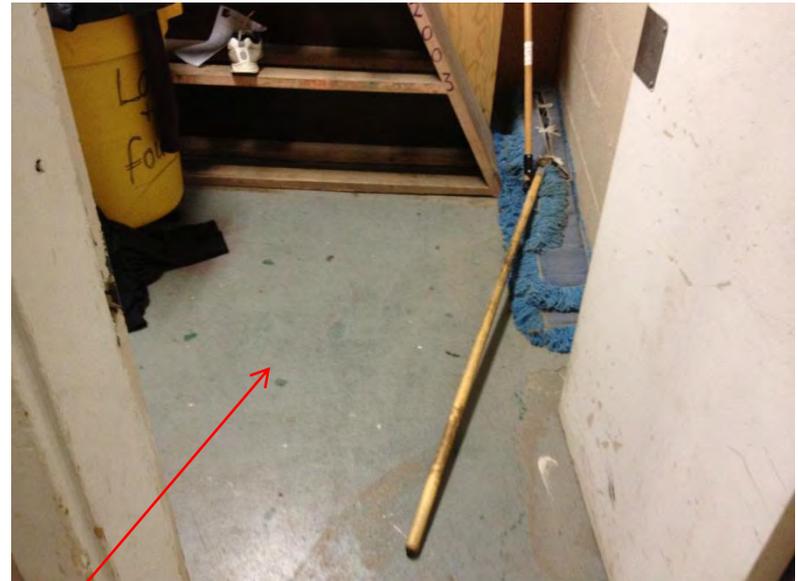
View of floor in Electrical Room in Building 6 near Cafeteria

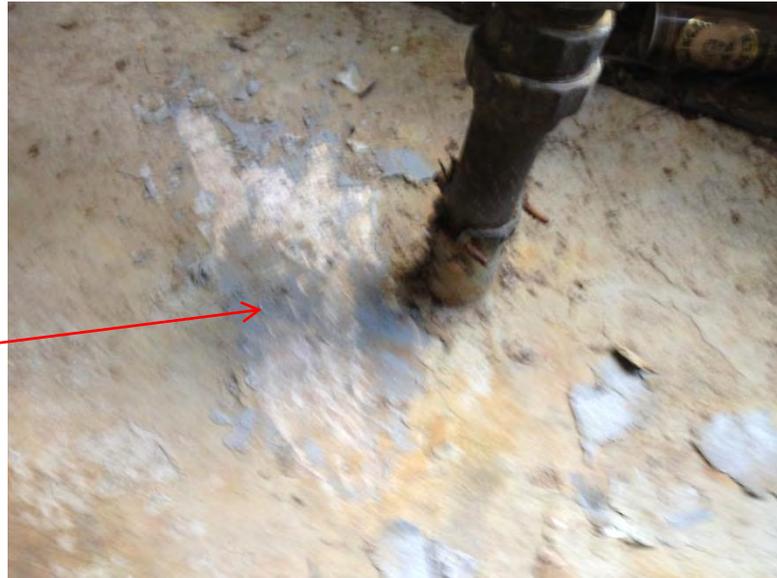
BM-7 (Medium Gray Floor Paint)

View of the floor in boiler room in Building 4
