INFRASTRUCTURE COMMITTEE MEETING

Monday, January 29, 2018

The following is our summary review of the results of the 2017 sewer system inspection that was conducted by Ted Berry Company, per Task Order No. 17. The scope of this Task Order is to provide ongoing engineering support including a review of the sewer inspection results, improvement recommendations, and support with implementation of recommendations.

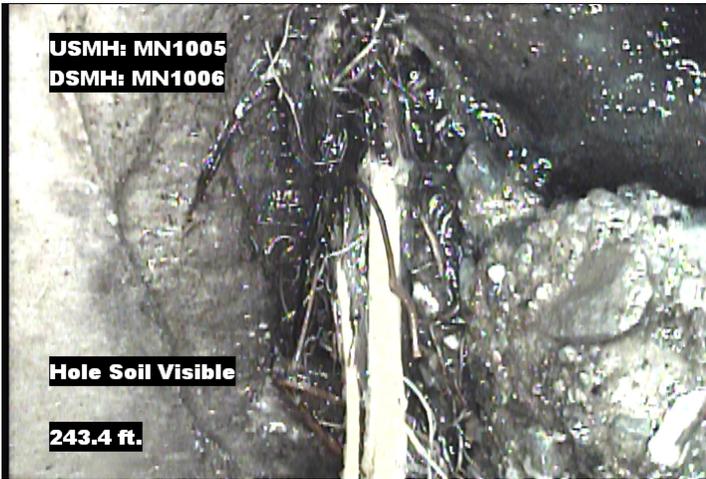
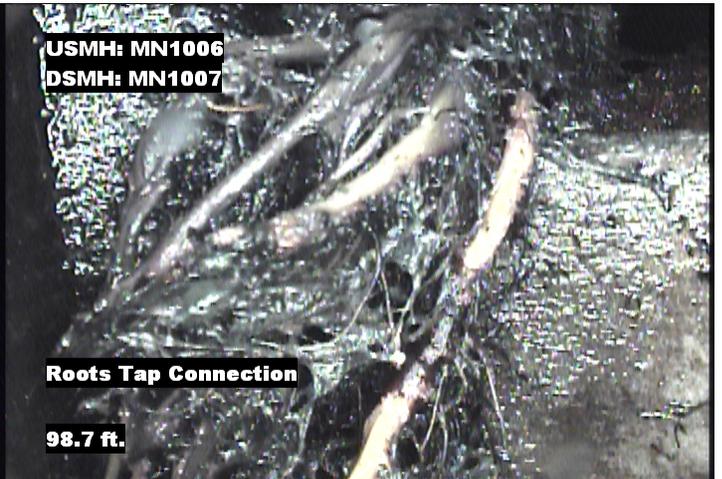
Main Road North (between Old County Rd and Mountain View Dr)

A section of sewer on Main Road North extending from Old County Road to Mountain View Drive consists of asbestos cement (AC) main and manholes constructed with masonry block. Some significant issues were noted in this section of sewer main, including holes in the pipe, infiltration, roots, and other pipe damage. Many of the manholes showed signs of degradation including missing mortar and brick, frames and risers in poor condition, and poor invert condition.

While this section of AC pipe and manholes was not previously identified as a Sewer Priority Area, the age and condition of the system warrants further consideration for rehabilitation. AC pipe was predominantly installed in the 1950's and 1960's, indicating an asset age exceeding 50 years. Gravity sewer mains are generally predicted to have a useful life of approximately 50 years.

- Replacement of all barrel-block manholes within the MDOT project area and replacement and/or rehabilitation of the two barrel-block manholes outside of the MDOT project area.
- Replacement of non-PVC service laterals along the AC main section within the MDOT project area.
- Lining repair of all existing AC main to restore its structural integrity and seal infiltration sources. This can occur after the MDOT project is complete.

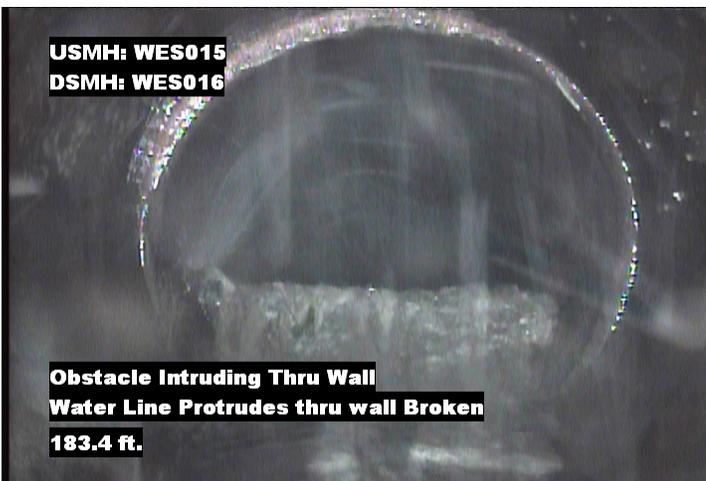
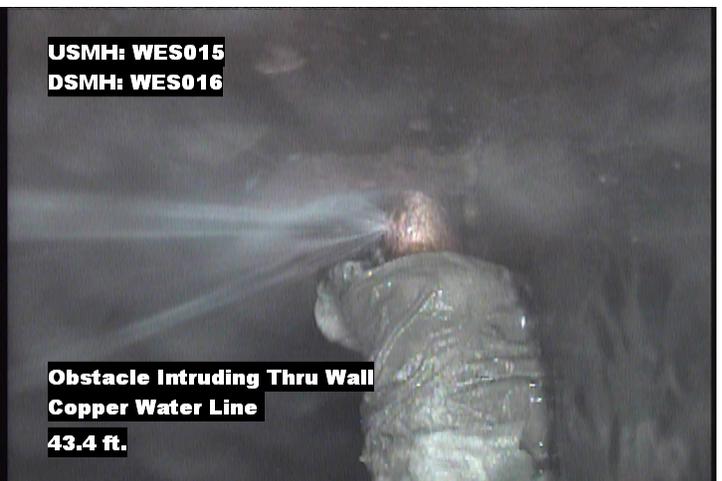
Western Ave: Water line broken (between Evergreen and Constitution)

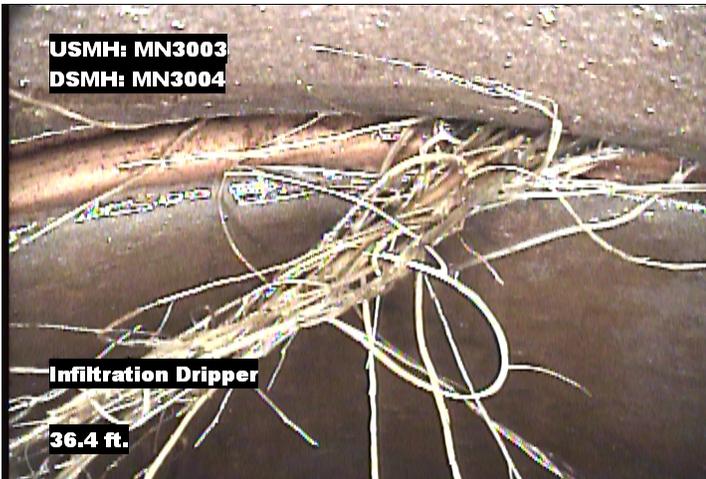
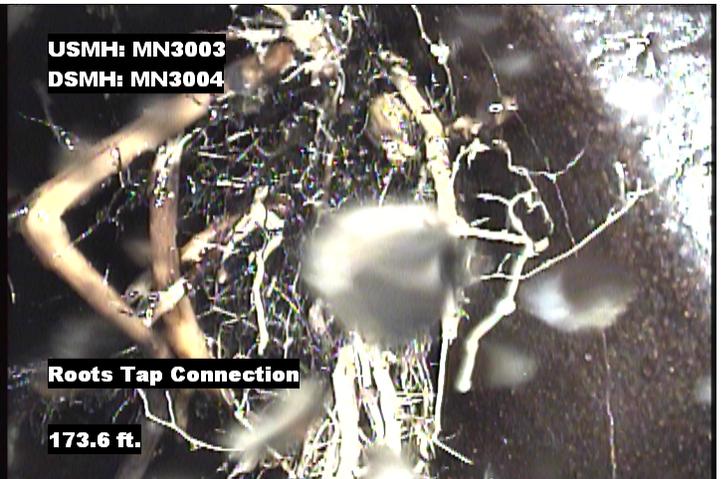
Main Road North (between superintendent's office and Cottage St)

The sewer main and manholes along this section of Main Road North is some of the oldest in the Hampden system and in poor condition. Piping consists of vitrified clay pipe (VCP) and manholes are constructed of brick. There are numerous structural pipe failures, holes, root growth, and active infiltration throughout this section of sewer main. Several of the manholes also have structural failures with barrel fractures, missing brick, and active infiltration. Grease deposition has been a known issue in this section of sewer as it serves several restaurants, exacerbated by intruding service laterals and root obstruction. Figures 5 through 7 show examples of these issues from the sewer inspection.

The condition of sewer along this section of Western Avenue warrants full replacement due to its poor condition. We recommend replacement through open-cut installation within the road right-of-way.

As this area is scheduled for water main replacement in 2018 by the Hampden Water District, we recommend that the Town coordinate sewer replacement to minimize overall construction impacts. We do not recommend scheduling this work to occur while the MDOT Route 1A reconstruction project is in progress due to the combined impact of construction projects on the Route 1A corridor. Pavement and sidewalk restoration will be required for this project due to the location of the sewer. Coordination water main and sewer replacement

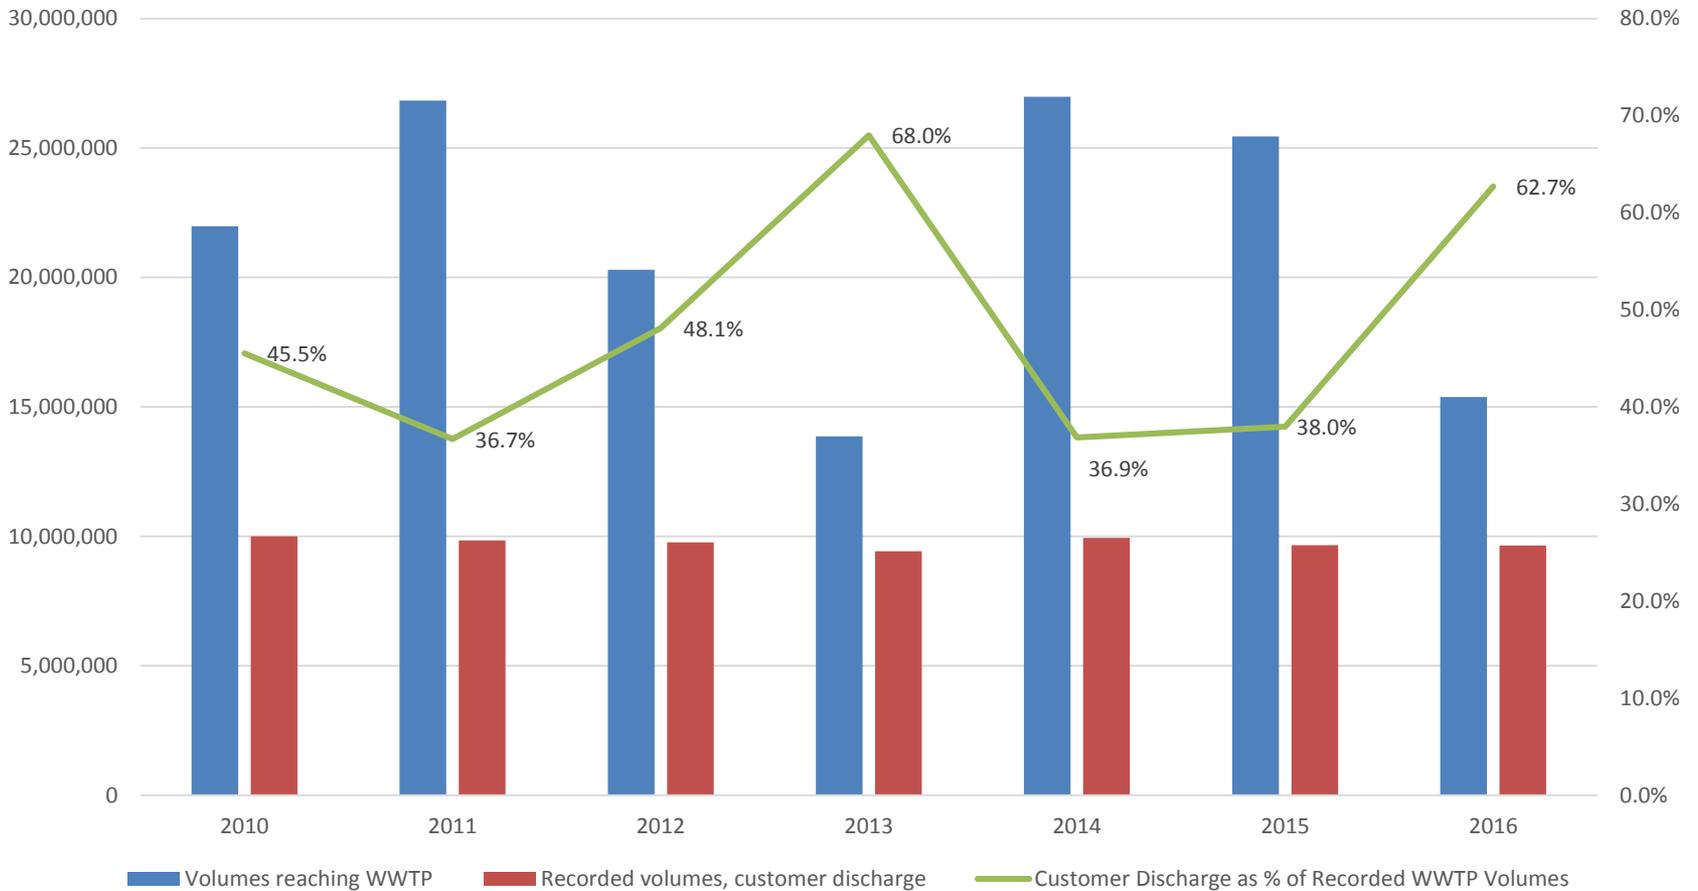
Hampden Sewer Billing Relative to Total Recorded Flows Discharged to Wastewater Treatment Plant, 2010 to 2016

Last year, invoiced sewer volumes only represented 62.7% of sewer volumes discharged to WWTP. Difference between invoiced volumes and volumes discharging to WWTP is assumed to reflect system Inflow & Infiltration (I/I)

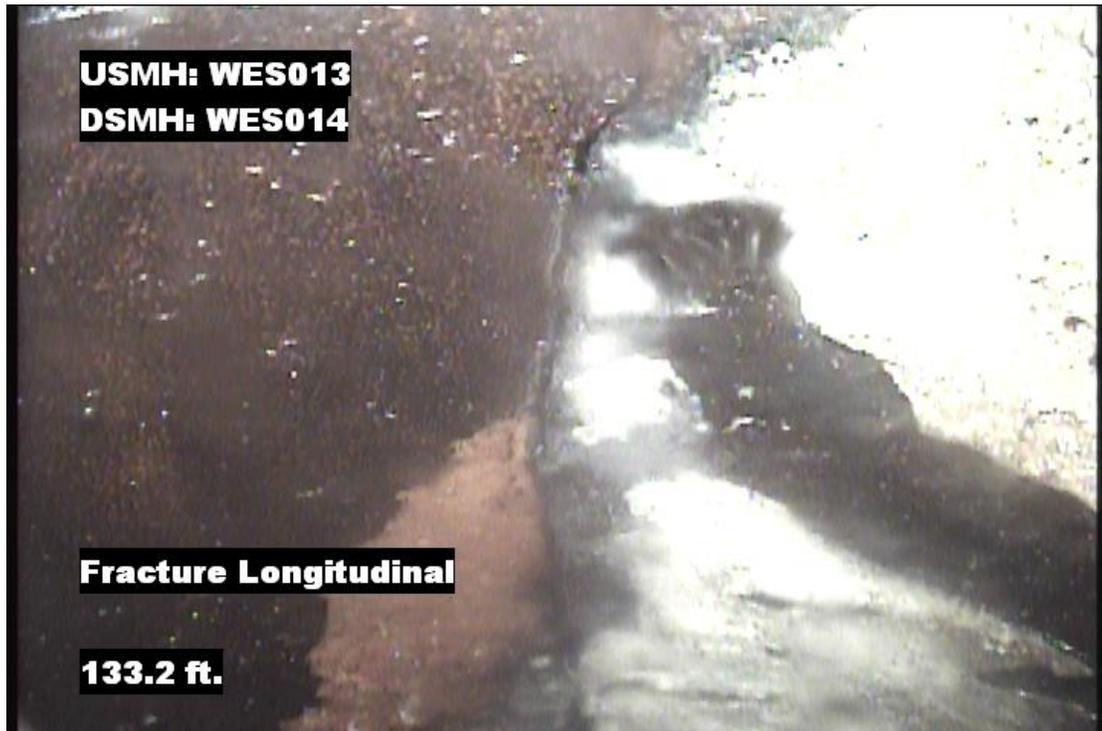
The sewer main and manholes along this section of Western Avenue expected to be impacted by the full reconstruction project are some of the oldest in the Hampden system and are in poor condition. Piping consists of vitrified clay pipe (VCP) and manholes are constructed of brick. There are numerous structural pipe failures, holes, and active infiltration throughout this section of sewer main. Several of the manholes also have structural failures with barrel-section fractures, missing brick and mortar, and active infiltration.

Figure 3: Example VCP Fracture

- Replacement of all gravity sewer and service laterals along Western Avenue.
- Replacement of gravity sewer and service laterals on Dewey Street to minimize future disruption.
 - We recommend replacement through open-cut installation within the road right-of-way to occur in advance of or concurrent with the scheduled road rehabilitation project.

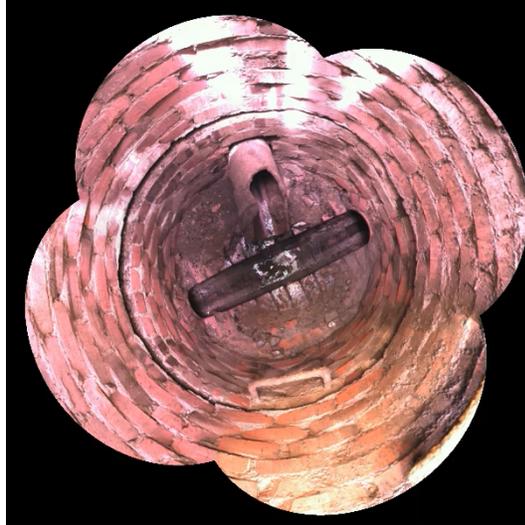
Figure 4: Example Manhole Barrel Fracture

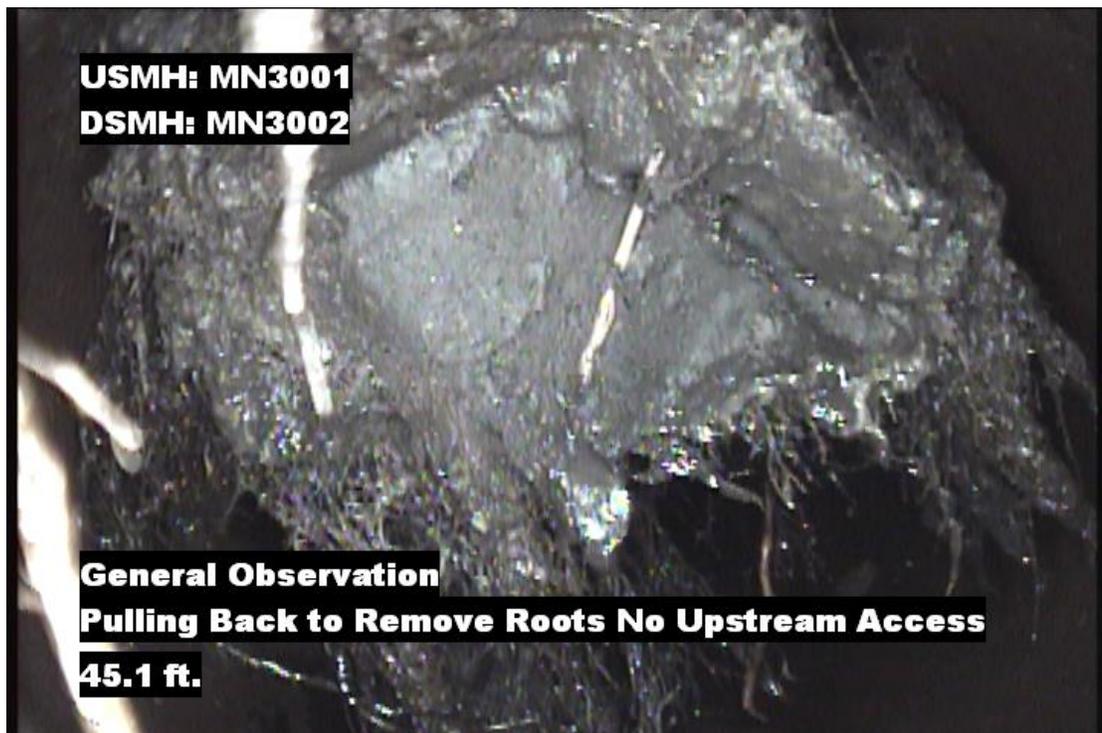
Figure 6: Example Root Intrusion
