**HAMPDEN ENVIRONMENTAL TRUST  
COMMITTEE MEETING**

## MEMORANDUM

**To:** Jim Chandler & Hampden Environmental Trust  
**From:** Matt Reynolds & Steve Rabasca  
**Date:** September 11, 2018  
**Subject:** Pine Tree Landfill –Post-Closure Monitoring Review & Update

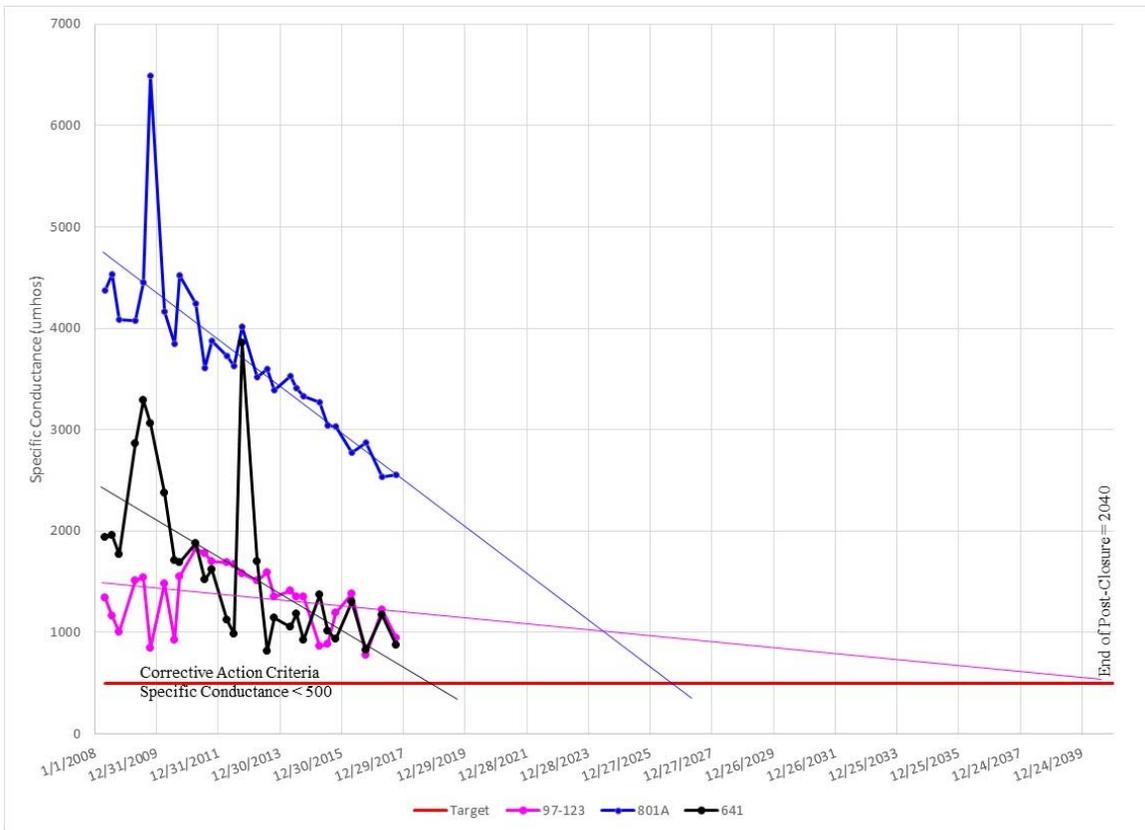
**Figure 2 – Water Quality Trends**

The 2017 Annual Report notes that 2017 was the 7<sup>th</sup> year of the 30-year post-closure monitoring period and there has been discussion regarding whether the current correction action systems are adequate to reach the corrective action criteria by the end of the 30-year post-closure period. Figure 2 shows the specific conductivity data and 2008 to 2017 trend for three example monitoring wells at the PTL site. MW-02-801A and well 641 are south of the landfill and have exhibited moderate to strong decreasing trends that suggest the potential to reach the Corrective Action Criteria well before the end of the Post-Closure period in 2040. Review of Figure 2 also shows that data from well 641 from 2013 to 2017 has been more variable with a weaker downward trend. Well 97-123 from northeast of the landfill shows a more gradual downward trend that suggests the potential to remain above the Corrective Action Criteria after 30 years.

These examples suggest that with continued diligent operation of the Corrective Action systems, many wells at the PTL site have the potential to reach the criteria within the 30-

year post-closure period. However as shown in Table 1, there are wells in the southwest and west of the landfill where there are increasing trends that may require additional corrective actions in the future.
