MAINE HISTORIC PRESERVATION COMMISSION
Historic Building/Structure Survey Form

1. PROPERTY NAME (HISTORIC): John W. Perkins, Jr. House
 2. PROPERTY NAME (OTHER): Benjamin W. Page, Warren R. Page, House
 3. STREET ADDRESS: Route 69 [Box 675] Map 1 lot 27
 4. TOWN: Hampden 5. COUNTY: Penobscot
 6. DATE RECORDED: Nov. 1993 7. SURVEYOR: Deborah Thompson
 8. OWNER NAME: Shirley R. + Ralph Cobb, SR ADDRESS: RFD 1 Box 675, Hampden ME 04944
 9. PRIMARY USE (PRESENT):
 SINGLE FAMILY AGRICULTURE _____ COMMERCIAL/TRADE _____ FUNERARY _____
 MULTI-FAMILY _____ GOVERNMENTAL _____ EDUCATION _____ HEALTH CARE _____
 INDUSTRY _____ RELIGIOUS _____ HOTEL _____ LANDSCAPE _____
 TRANSPORTATION _____ DEFENSE _____ SUMMER COTTAGE/CAMP _____ SOCIAL _____
 RECREATION/CULTURE _____ UNKNOWN _____ OTHER _____

ROUTE 69, PHASE 5

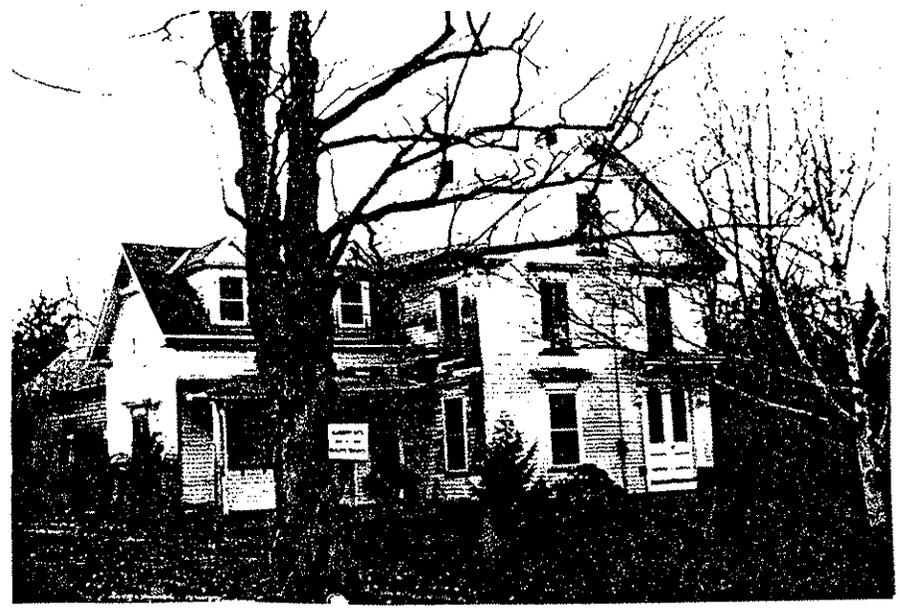
1, 27

25. DOCUMENTED DATE OF CONSTRUCTION: By 1856 26. ESTIMATED DATE OF CONSTRUCTION: Part 1851 (not in Perkins's list)
27. DATE MAJOR ADDITIONS/ALTERATIONS: Intact on exterior even to porch posts, fine door cap.

28. ARCHITECT: If equally intact on interior might describe NH nomination; needs restoration!! 29. CONTRACTOR (NOTE IF SAME AS 28):
30. ORIGINAL OWNER: John W. Perkins, Jr. by 1856 - 1864

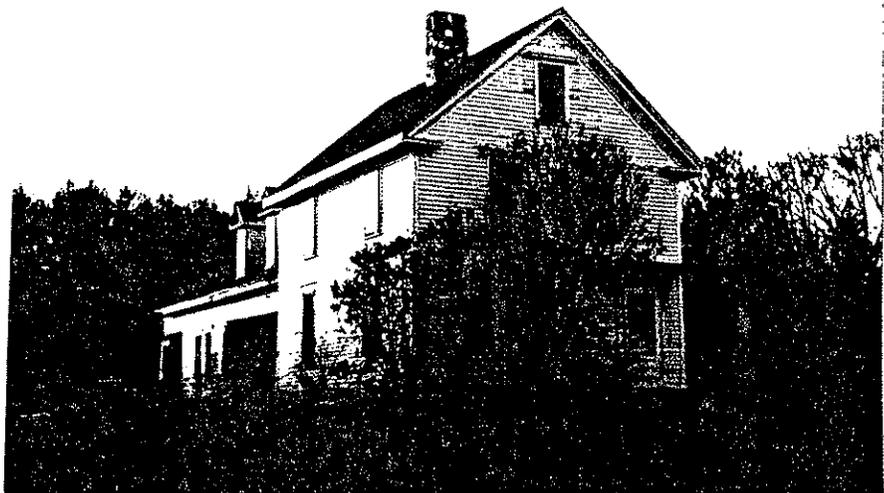
1134D

25. DOCUMENTED DATE OF CONSTRUCTION: By 1853 26. ESTIMATED DATE OF CONSTRUCTION: _____
27. DATE MAJOR ADDITIONS/ALTERATIONS: Porch framed in replaced, front 3' piece remodeled as Colonial Revival at head of the chimney. Chimney rebuilt. Bero's gone

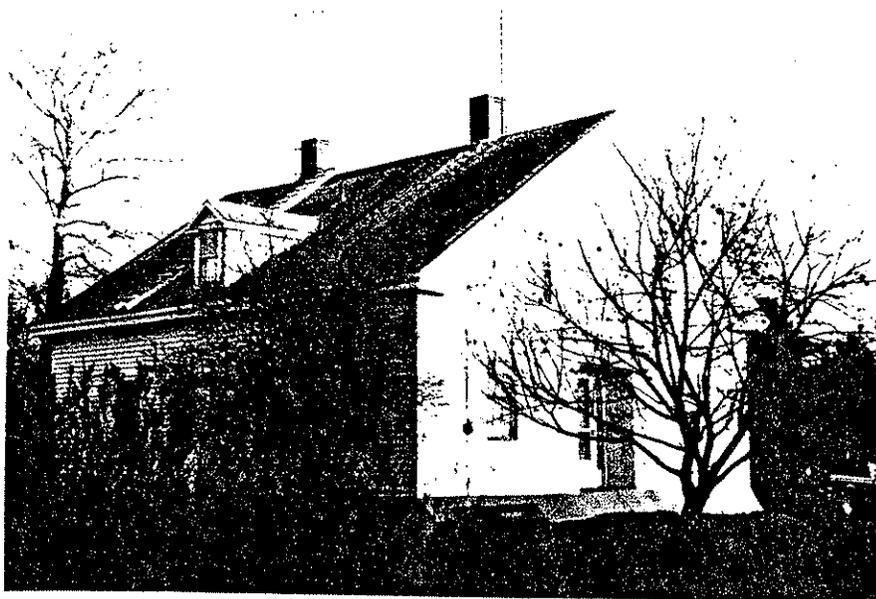
7115

* present facade
(due to Italian
change)

25. DOCUMENTED DATE OF CONSTRUCTION: By 1843 26. ESTIMATED DATE OF CONSTRUCTION: Ca. 1833
27. DATE MAJOR ADDITIONS/ALTERATIONS: Ca. 1990, sided, trim removed
28. ARCHITECT: _____ 29. CONTRACTOR (NOTE IF SAME AS 28): _____
30. ORIGINAL OWNER: Joseph H. Sawyer 1832-1880
31. SUBSEQUENT SIGNIFICANT OWNER: Henry D. Smith 1901-22
Edith C. Downes 1922-55
32. CULTURAL/ETHNIC AFFILIATION: ENGLISH FRENCH ACADIAN NATIVE AMERICAN SCOTTISH
 FRENCH CANADIAN EAST EUROPEAN IRISH
 OTHER

===== present facade; original facade faint S. =====

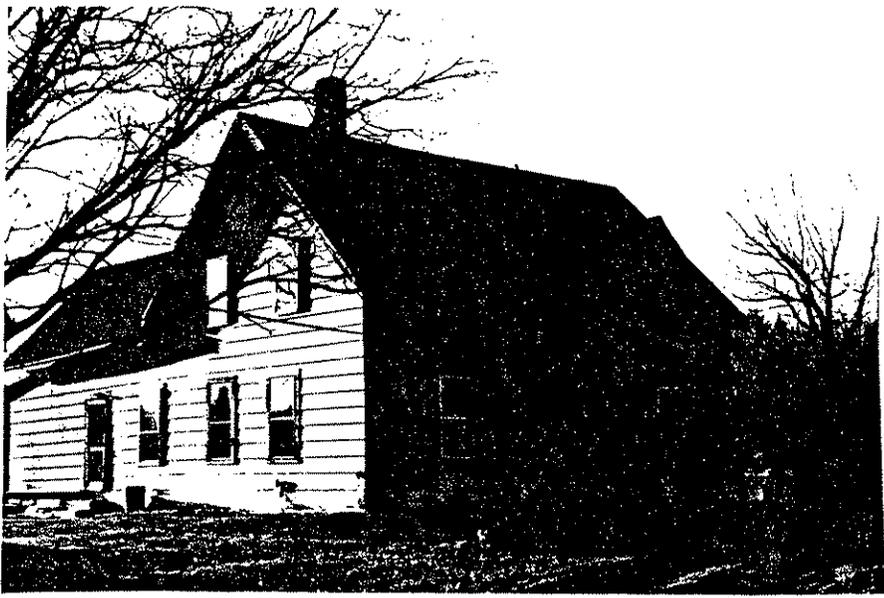
4,7

19. CHIMNEY PLACEMENT: INTERIOR INTERIOR FRONT/REAR CENTER INTERIOR END
EXTERIOR OTHER one apparently removed
20. ROOF CONFIGURATION: GABLE SIDE GABLE FRONT HIP MANSARD
FLAT GAMBREL PARAPET GABLE SHED
CROSS GABLE COMPOUND OTHER

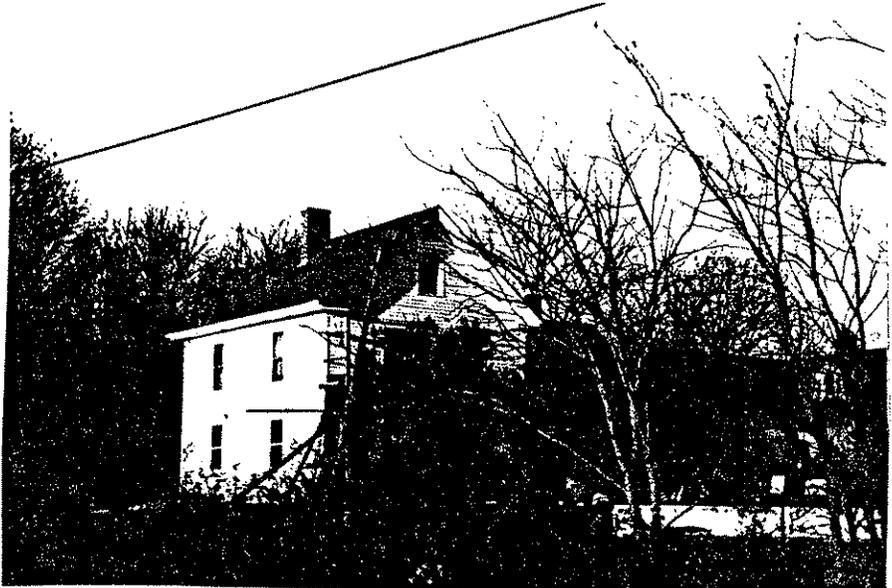
4, 16

34. COMMENTS/SOURCES: *Chain of title missing before Jefferson Page but supplied by 1859 map. PRD 4/19/69; 596/365; 706/120; 2336/339. Williams since 1969. HHS, Tax records show in Charles Page's list but with a rise in value from \$175 ⁽¹⁸⁴⁷⁾ house & barn to \$300 in 1852, suggesting the construction of the Italianate main part of the house next to the older*

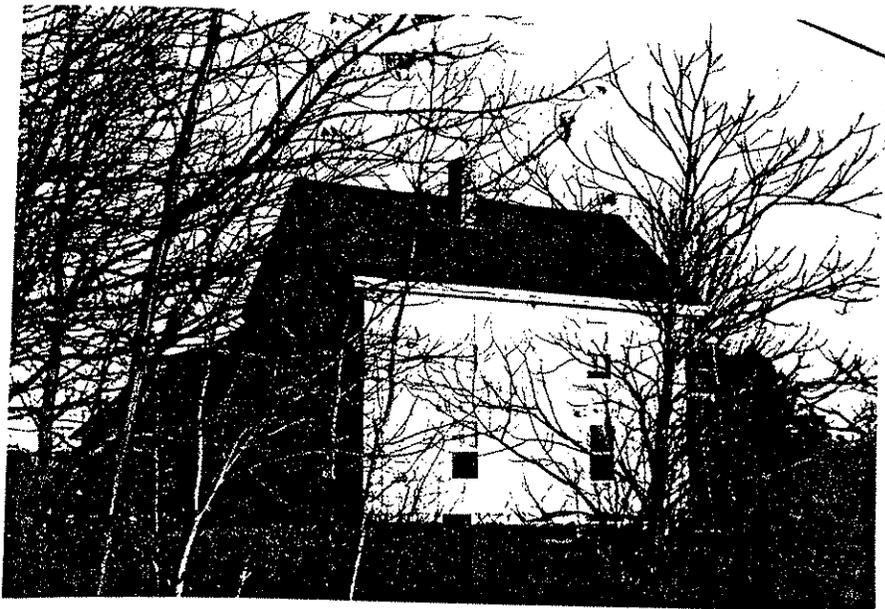
Charles Page House, north elevation
Route 69 Map 4 Lot 16

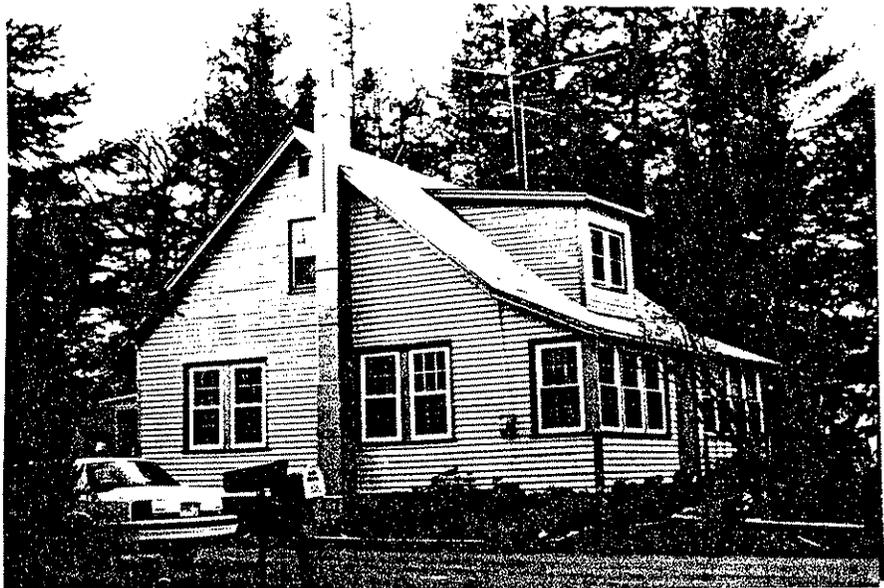
16. PORCH: ATTACHED ENGAGED *removed* ONE STORY MORE THAN ONE STORY
 FULL WIDTH WRAPAROUND SLEEPING PORCH SECONDARY PORCH
17. PLAN: HALL AND PARLOR 1/2 CAPE CENTRAL HALL SIDE HALL BACK HALL IRREGULAR
 OTHER Bungalow

25. DOCUMENTED DATE OF CONSTRUCTION: 1934-35 26. ESTIMATED DATE OF CONSTRUCTION: _____
27. DATE MAJOR ADDITIONS/ALTERATIONS: Windows replaced, new clapboard siding and chimney c. 1950s
