Phase I Environmental Site Assessment Report

Hampden Academy Property
1 Main Road North
Hampden, Maine 04444

**Subject: Phase I Environmental Site Assessment Report
Hampden Academy Property
1 Main Road North
Hampden, Maine**

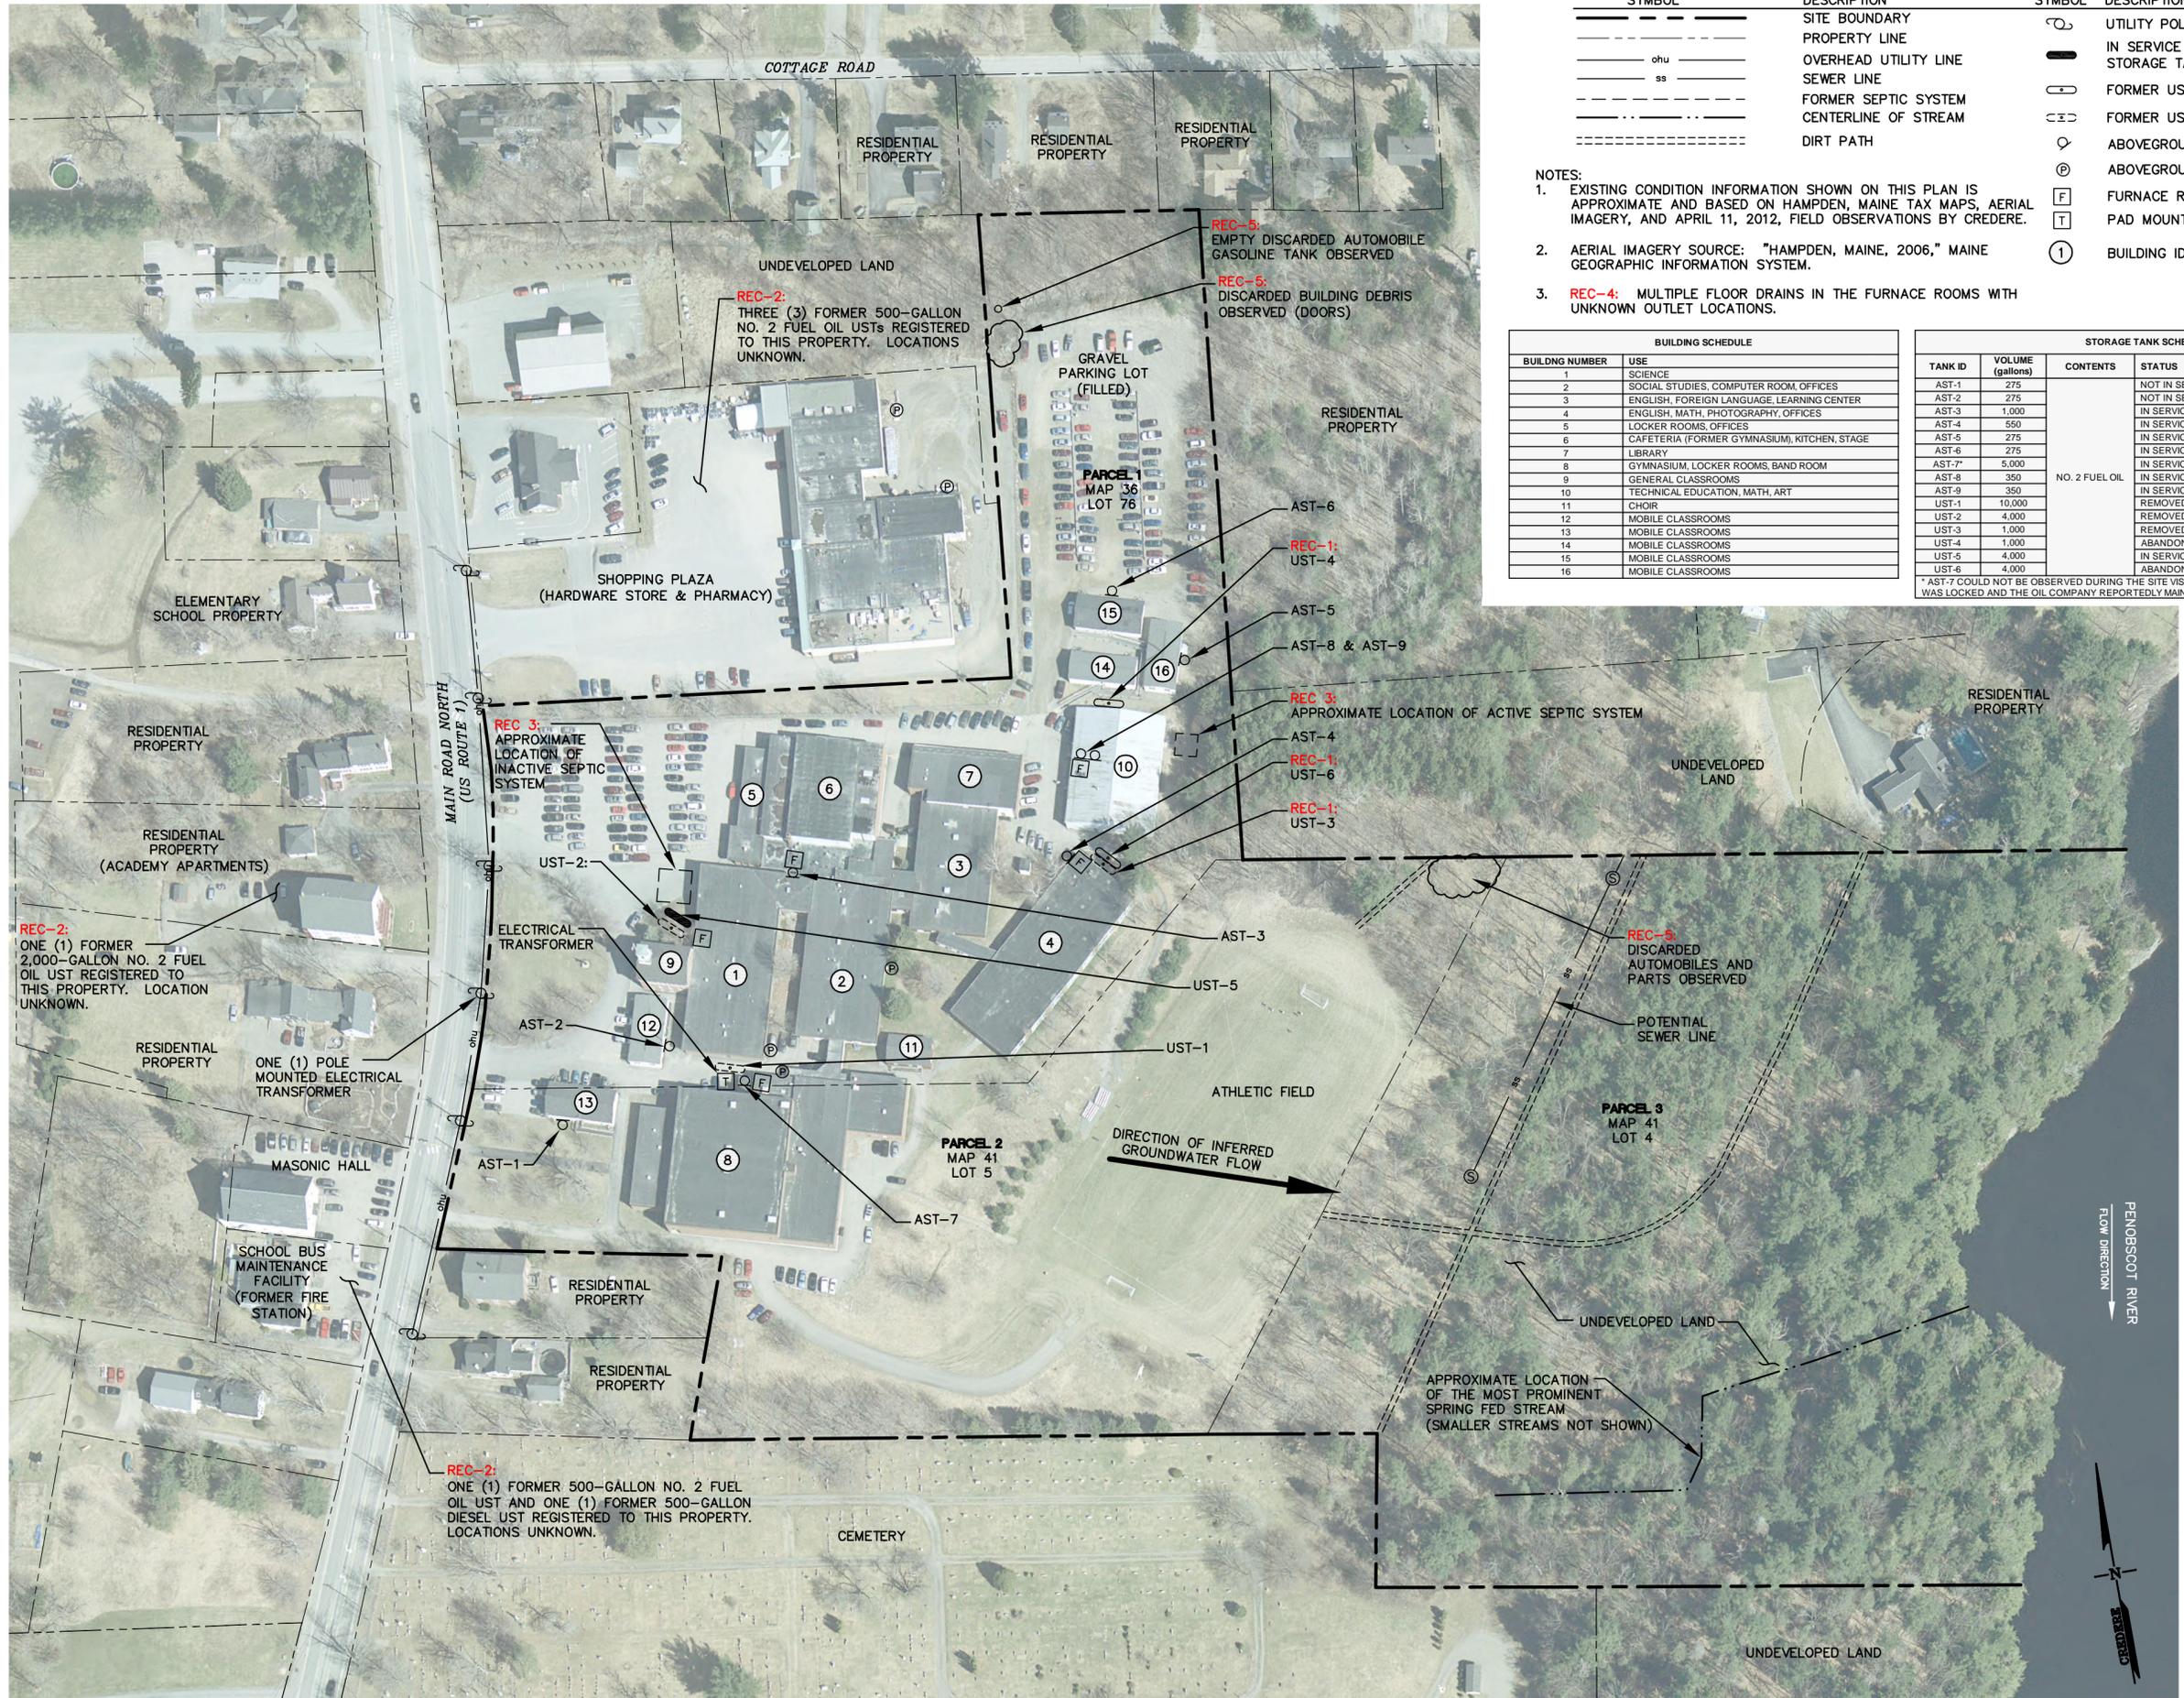
**FIGURE 2
DETAILED SITE PLAN**
HAMPDEN ACADEMY PROPERTY
1 MAIN ROAD NORTH
HAMPDEN, MAINE

- NOTES:
- EXISTING CONDITION INFORMATION SHOWN ON THIS PLAN IS APPROXIMATE AND BASED ON HAMPDEN, MAINE TAX MAPS, AERIAL IMAGERY, AND APRIL 11, 2012, FIELD OBSERVATIONS BY CREDERE.
 - AERIAL IMAGERY SOURCE: "HAMPDEN, MAINE, 2006," MAINE GEOGRAPHIC INFORMATION SYSTEM.
 - REC-4: MULTIPLE FLOOR DRAINS IN THE FURNACE ROOMS WITH UNKNOWN OUTLET LOCATIONS.

Figure 1 locates the Site on the Hampden, Maine quadrangle prepared by the United States Geological Survey (USGS). **Figure 2** is a Site plan based on observations made during Credere's Site visit and the review of Site records.

Buildings 1 through 10 are heated by a combination of five (5) No. 2 fuel oil-fired boilers, which are supplied by a combination of five (5) aboveground storage tanks (ASTs) and one (1) underground storage tank (UST). Buildings 11 through 14 are heated with individual electric heaters. Buildings 15 and 16 are heated by individual oil-fired heating units, which are supplied by two (2) separate ASTs located adjacent to the buildings. See **Figure 2** for locations of USTs, ASTs, and furnace rooms.
